# TALKING TRASH II: A RETURN TO DEBRIS REMOVAL

*J. F. Sadler, Jr.*  
*CELRN-EP-D*  
*(615)736-5665*

## INTRODUCTION

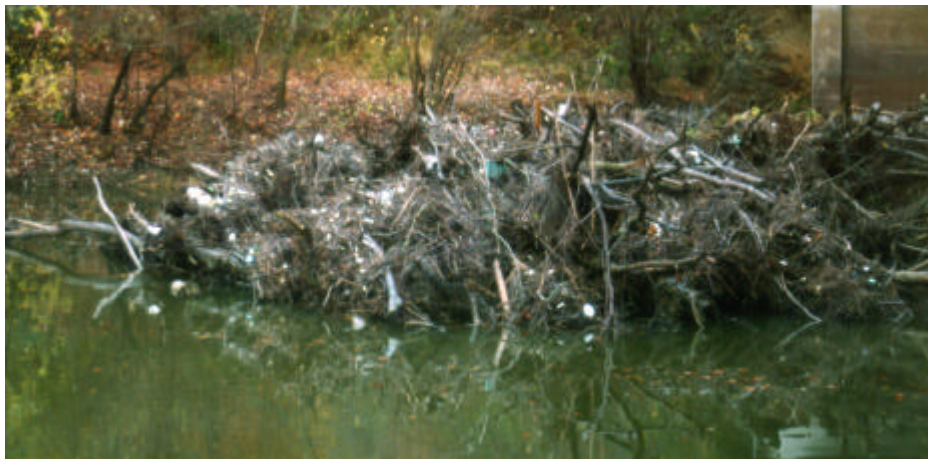
FIGURE 1 - TYPICAL DEBRIS BUILD-UP NEAR LAKE CUMBERLAND, KY

The accumulation of floating drift and debris is a universal problem.

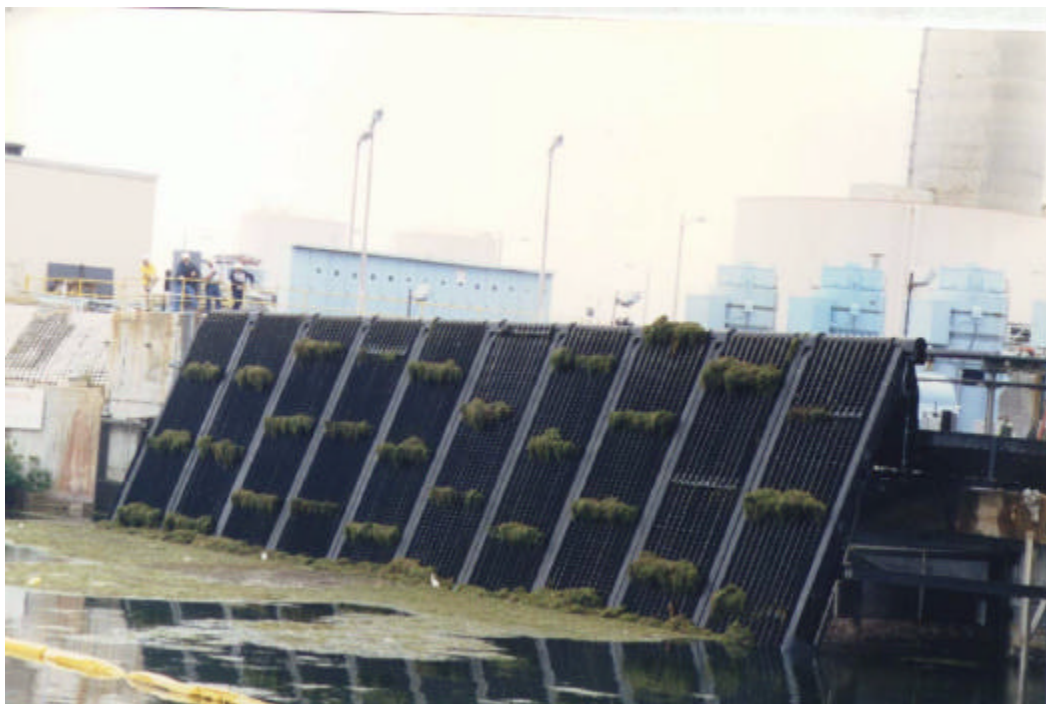
FIGURE 2 - DUPERON SELF-CLEANING DEBRIS REMOVAL SYSTEM

velocity to move the debris toward the trashrack and then teeth or pins on motor driven chains would lift the trash (both submerged and floating) to the conveyors and subsequently to a collection area. The continuous operation enhanced the system effectiveness. Debris bound on lifting pins would be released from that pin and lifted by a subsequent pin. The racks had to be large enough to cover all three intakes, approximately 60 feet high by 25 feet wide. Conceptual layouts of the system and preliminary computations assured that self-cleaning trashracks could be constructed large enough for this project.

The RFP required a 50% design submittal with the successful bidder responsible for final design. The trashrack was to lift a 36" diameter, 60 foot long log as well as mats comprised of debris such as vegetation, bottles and tires. The trashrack was required to operate continuously with a reset feature that would allow oversized material to be released from binding. A conveying system which would move the lifted debris to a collection bin was also required. The one rigid requirement for these trashracks was painting. The high degree of abrasion as well as the continuous submergence of the trashracks were our main concerns. The Construction Engineering Research Laboratory (CERL) recommended an initial coat of zinc-rich vinyl and subsequent coats of vinyl with added abrasives.

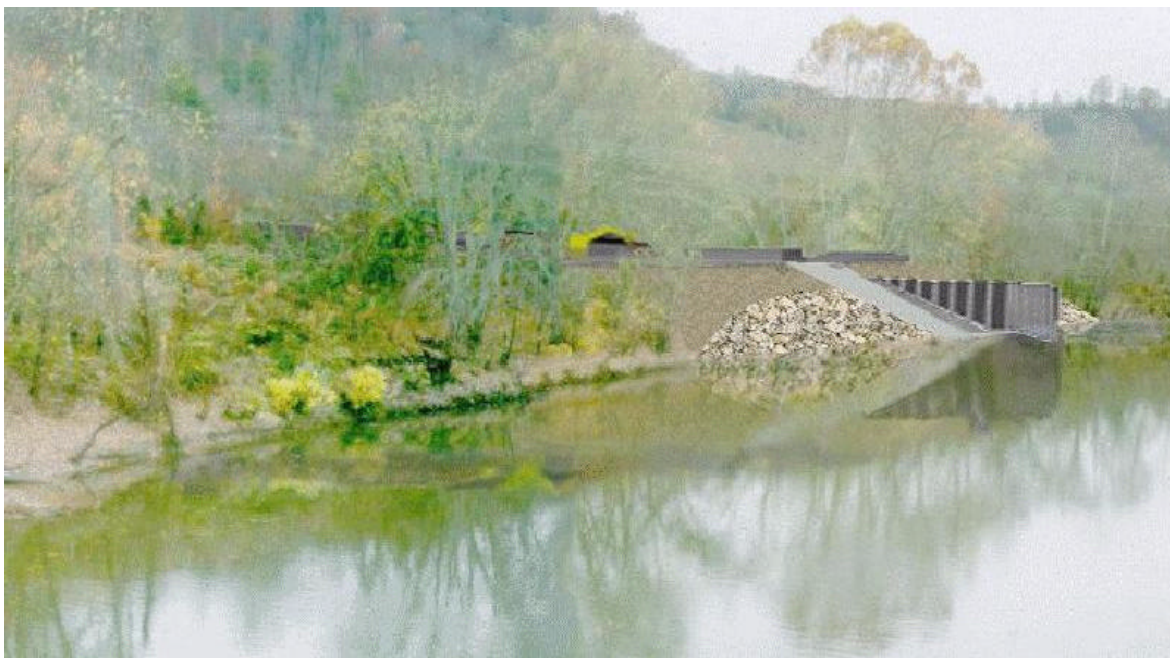
FIGURE 6 - CONCEPTUAL RENDERING OF PROPOSED COLLECTION SYSTEM

The system consists of a fixed glance rack extending approximately 100 feet into the Cumberland River at a thirty degree angle to the flow.

The rack extends an additional 130 feet up the bank to collect to about the 10-year flood event. Above that flood event, the flood plain is quite expansive and debris tends to spread out. After flood events, a removal device, such as a trackhoe, will remove the collected debris and deposit it into a staging area. The debris will then be sorted and dispositioned. Some of the woody debris will be either mulched for volume reduction or cut into firewood. Garbage and recycling bins will be provided for the cultural waste. A management plan for potential hazardous waste is being developed. An optional floating glance boom could enhance the capture effectiveness, dependent on model results.
